SEE Test Report V1.0  
Heavy ion SEE test of SIDECAR ASIC from TELEDYNE/UMC  
Christian Poivey<sup>1</sup>, Ray Ladbury<sup>2</sup>, Kevin Boyce<sup>2</sup>, Raphael Ricardo<sup>3</sup>, Markus Loose<sup>3</sup>

Test Date(s): June 26-27, 2007

Report Date: September 24, 2007

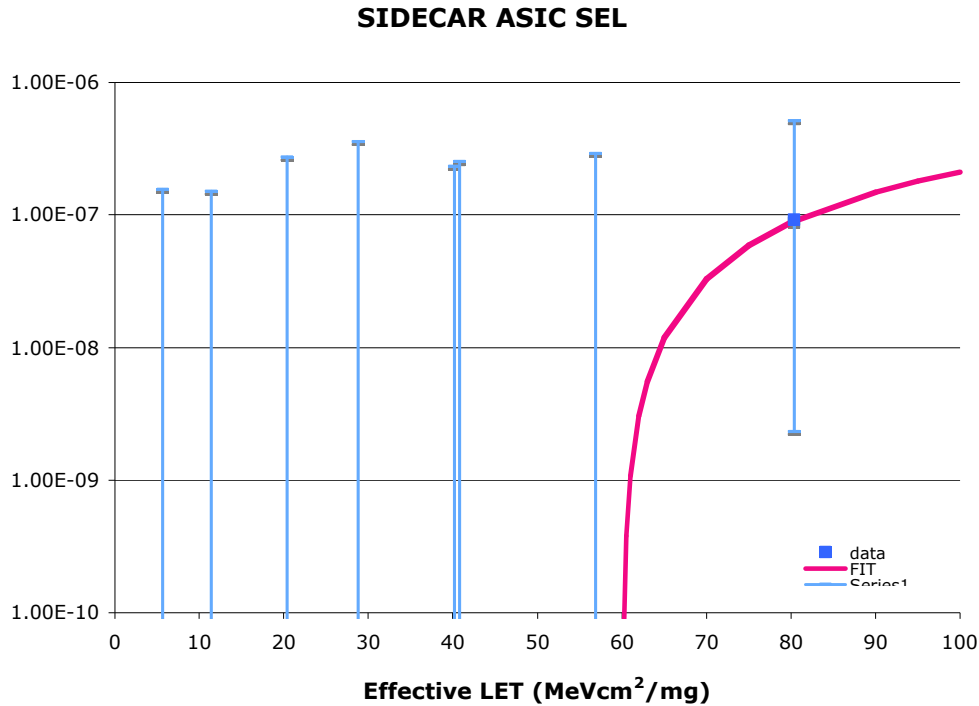
Figure 2: SEL cross-section curve

Test log is shown in Appendix. Table 3 gives a summary of SEL test results. Minimum and maximum confidence limits are 95% confidence limits of measured cross-sections. Only one SEL event was observed during the test. SEL event was observed on Vdd2.5 power supply at the highest tested LET of 80 MeVcm<sup>2</sup>/mg and at high temperature. SEL current was about 35 mA. DUT recovered after power cycle.

During one irradiation run, run 3, we also observed one over-current on Vdda. Vdda reached the 10mA threshold that was initially set for SEL. Over-current condition did not disappear after power cycle. After analysis, it appeared that it was a normal thermal increase of power supply currents, and SEL threshold limits were changed. Figure 2 shows the SEL cross-section curve. It should be noted that with only 1 event, test statistics is very low. SEL LET threshold can be anywhere between 56.9 and 80.4 MeVcm<sup>2</sup>/mg.

SIDECAR ASIC has a low sensitivity to SEL with a LET threshold greater than 59  $\text{MeVcm}^2/\text{mg}$ . With a rate of  $1.9\text{E-}16$  SEL/day on HST orbit, the probability to have a SEL during the 5-year mission is quasi negligible. SIDECAR ASIC SEL sensitive area was not found during irradiation with the laser. This may be an indication that the event observed was not an actual SEL, but a bus contention in the device. It should be noted that the SEL laser scan was coarse (manual scan). It is therefore possible that we missed the SEL sensitive area.

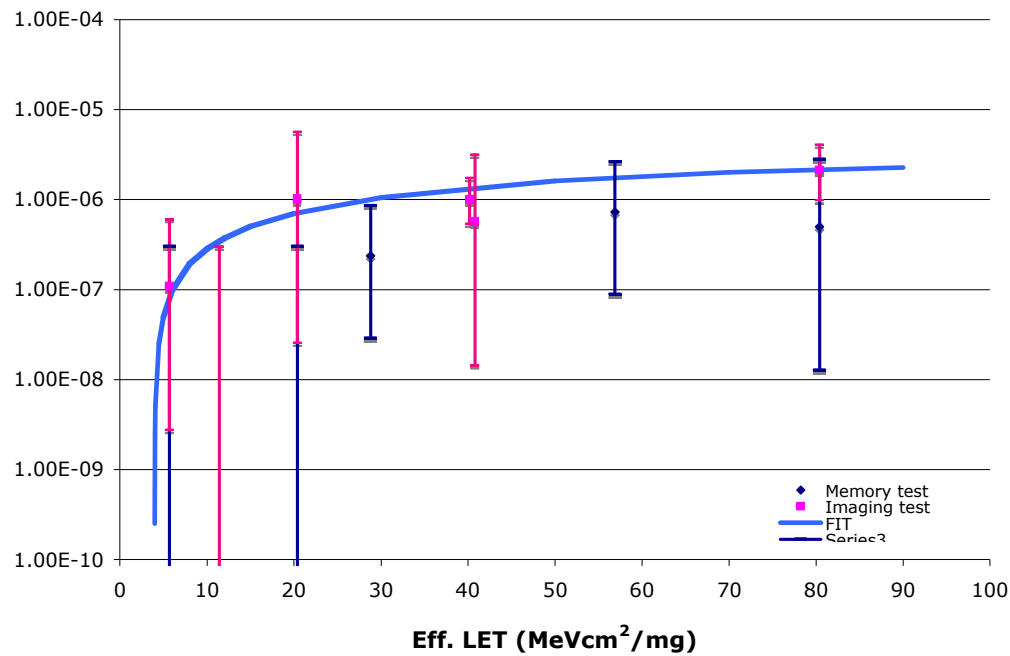
Figure 3: SEFI cross-section curve

Summary of SEFI test results is shown in Table 4. Generally a reset is sufficient to recover from a SEFI. But on one occurrence during a memory test (run 29), processor halted and a power cycle was necessary to recover. Figure 3 shows a plot of SEFI cross-sections versus LET. We can see that DUT is little bit less sensitive with the memory program. DUT is sensitive to heavy ion induced SEFI down to a LET of 5.7 MeVcm<sup>2</sup>/mg. This indicates a possible sensitivity to proton-induced SEFIs.

We don't know the cause of SEFI. One possible cause of SEFI is the occurrence of uncorrectable errors in an instruction code word. These double errors were unexpected because each of the 22 bits composing an instruction word are far apart (~200  $\mu$ m). Fluxes were low enough and scrubbing fast enough (1.6ms) to assure that the probability of two single particles hitting the same memory word is very low. Another issue is that digital voltage Vdd2.5 was set at 2V instead of 2.5V. It is known that reducing power supply voltage increases SEU sensitivity.

SIDECAR ASIC has a moderate sensitivity to SEFI. With a rate of  $4\text{E-}7$  SEFI/day on HST orbit, the probability to have a SEFI during the 5-year mission is about  $1\text{E-}4$ . Proton-induced upset may contribute to the SEFI rate. For example, assuming a SEFI proton cross-section of  $10^{-13} \text{cm}^2/\text{dev}$ , the SEFI rate will be increased by a factor 5. We would need more data to confirm that. However, given that the SIDECAR ASIC can be reset or power-cycled should a SEFI occur, these SEFI rates will have no significant impact on the mission.
